# MARYLAND INVENTORY OF HISTORIC PROPERTIES HISTORIC BRIDGE INVENTORY MARYLAND STATE HIGHWAY ADMINISTRATION MARYLAND HISTORICAL TRUST

NAME AND SHA NO.: 10014

| LOCATION Road Name and Number: MD 28 over Tuscarora Creek City/Town: Point of Rocks X vicinity County: Frederick |

Bridge 10014 is a double-span concrete girder bridge with a total length of 51'. Each span measures 23' long and the two-lane roadway is 24' wide with a bituminous concrete surface and 2' shoulders. A steel W-beam guardrail has been attached to the solid concrete parapets which feature five panels, alternating rectangular and square panels, per span.

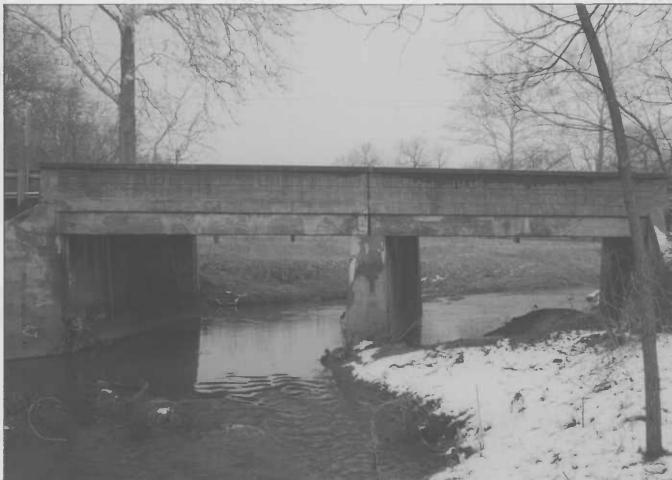
Number 19 of 36439

Description ELEVATION LOOKING NORTH

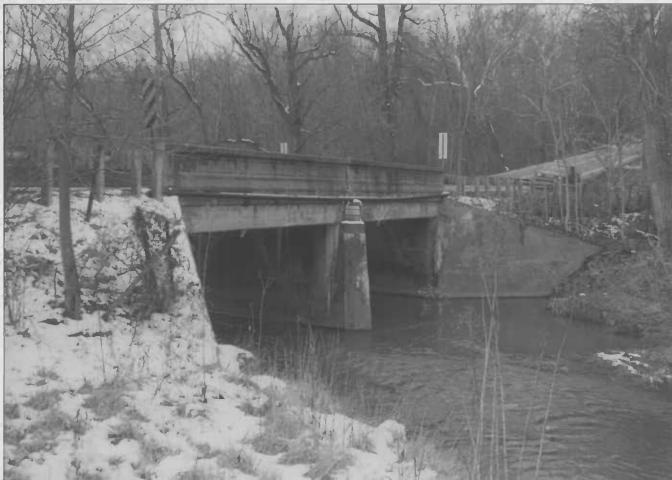
Number 28 of 34 39

| Inventory # <u>F-1-34</u> |
|---|
| Description ELEVATION WOKING SOUTH |

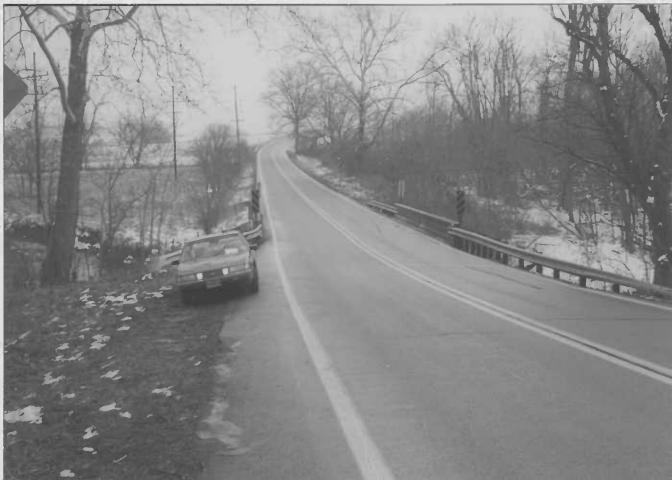
Number 322 of 34 34

| Name 10014-MD 28 OVER TUSCARORA County/State FREDERICK COUNTY/MC | CREEK |
|--|---|
| Description APPROACH EAST | |

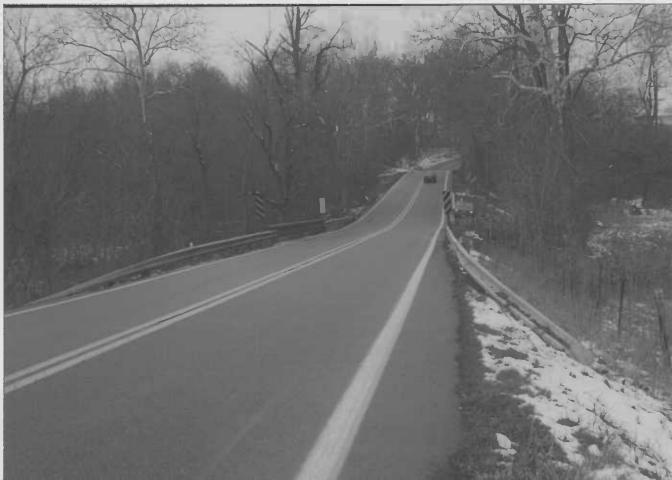
| Inventory # $F-1-34$ |
|---|
| Number 27 of 24 |

| Inventory # $F-1-34$ |
|---|
| Description APPRVACHWEST |
